Experience in diverting and containing lava flow by barriers constructed from in situ material during the 2021 Geldingadalir volcanic eruption

Fjóla G. Sigtryggisdóttir¹ · Hörn Hrafnisdóttir² · Jón Haukur Steingrímsson³ · Ari Guðmundsson²

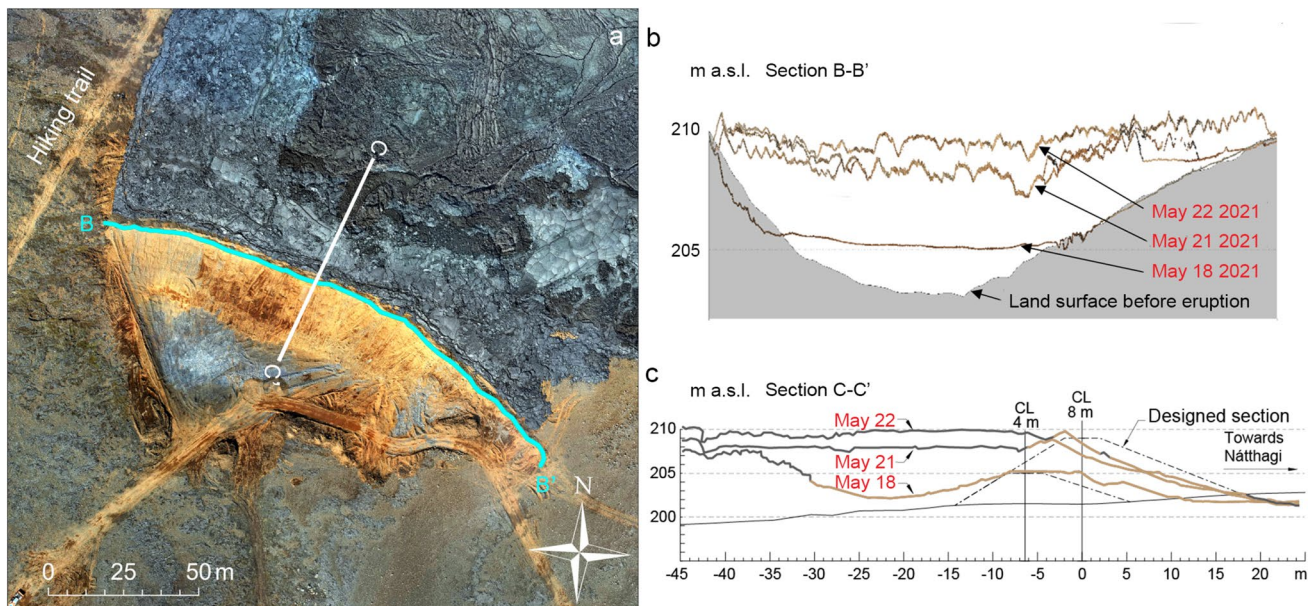
Fig. 6 The West Dam. (a) Plan view (picture from May 22). (b) Longitudinal section B-B' (along the cyan line on the plan view) as measured by drone survey on May 18, 21, and 22, 2021. (c) Cross section C-C' as measured by drone survey on May 18, 21, and 22, 2021, along with the designed cross section. The black measurement lines represent the surface of the lava, while brownish lines represent the dam's and soil surface. For the May 18 measurement, the brownish line also outlines the heap and the channel between the heap and the dam. The May 18 outline of the downstream slope of the elongated

heap upstream the dam meets the outline of the lava 30.5 m upstream the centreline (CL) of the designed dam crest (CL 8 m). The May 21 dam outlines show a status during the bulldozing activities on that day, while the May 22 dam outlines present the final bulldozed dam section as completed in the evening of May 21. Data source: The base map is based on data from the National Land Survey of Iceland (www.lmi.is), the IcelandDEM. Data for the lava and the dam: Drone surveys by Svarmi

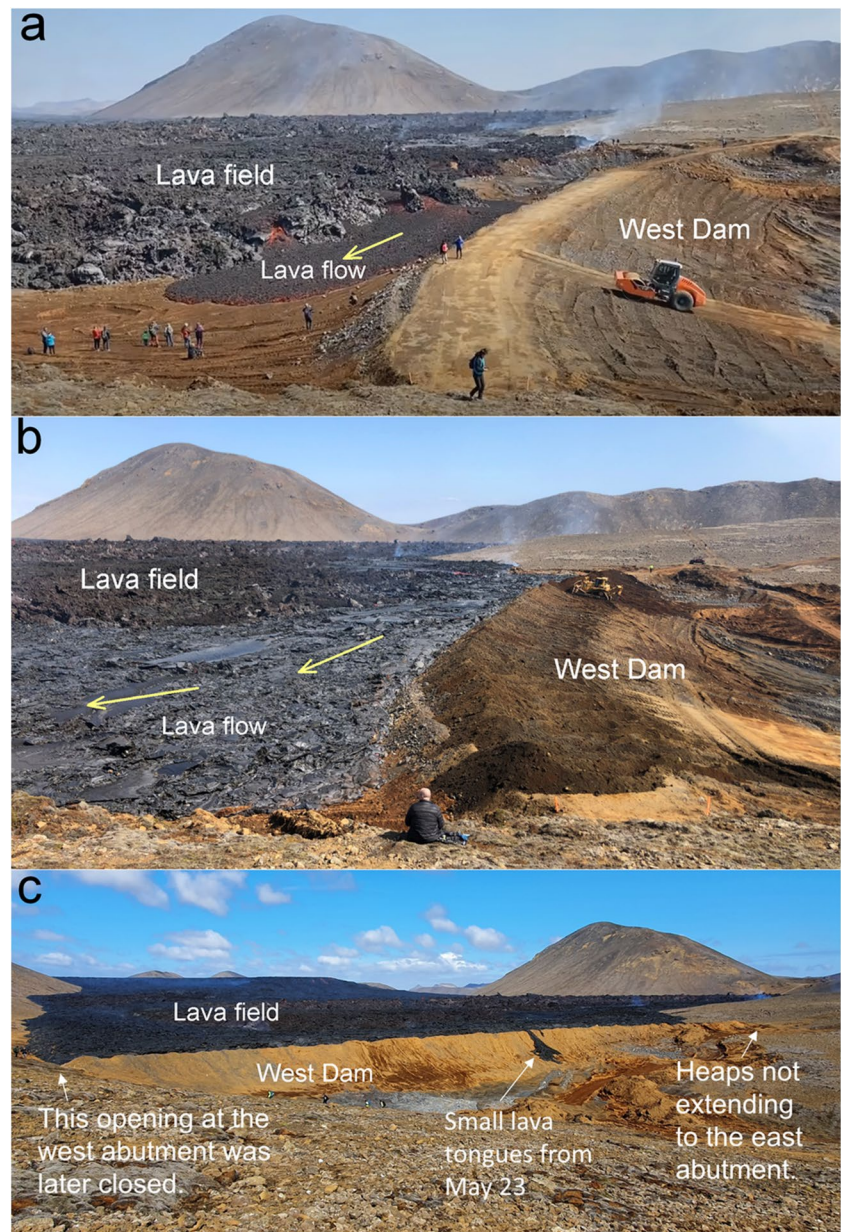
The site engineer again instructed emergency responses on the West Dam with bulldozing of the downstream dam slope resulting in heaps on the dam crest (Fig. 7b). Thereby the volume of the dam body was reduced for the purpose of heightening the dam with the heaps. The dam height reached about 209 to 210 m a.s.l. and the crest comprised of uneven tops of loose earth material (Fig. 6b).

The downstream slope of the dam after the bulldozing was about 45° (1H:1V) for the uppermost 2 to 3 m (for the emergency heaps on the top) and about $22\text{--}30^\circ$ (1.7–2.5H:1V) on the slope below. The inclination of the upstream slope was about $26\text{--}33^\circ$ (1.5–2H:1V). However, when the dam height was increased, an extension was required towards the abutments. This extension towards the east was provided with elongated heap of loose material, however, ending abruptly at the easternmost end (see Fig. 7c).

Fig. 7 Lava flows towards the West Dam on May 21 and resulting changes in the dam's geometry. **(a)** Lava flow on May 21. The West Dam completed with a 7-m-wide crest and a vibrating roller compacts the downstream slope (yellow arrow indicates the main lava flow direction other than spreading in the area between the dam and lava field) (view towards east) (courtesy of Bernd Kliebhan, snapshot from YouTube video <https://www.youtube.com/watch?v=KvfDkDEXEhk>). **(b)** View towards east on May 21. Bulldozing to form heaps at the dam crest after the main lava flow (yellow arrow indicates the main lava flow direction other than spreading). **(c)** View towards northeast on May 25. The heaps do not fully extend to the abutments and a lava tongue has crawled over the dam on May 23

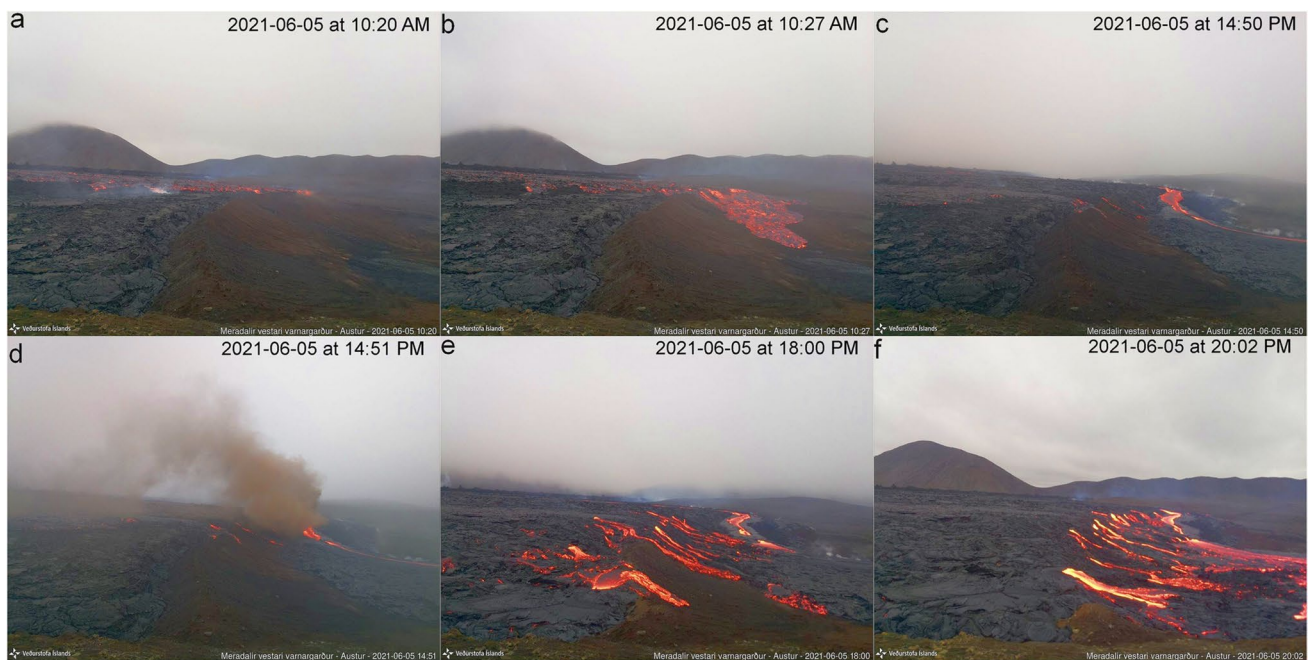
Fig. 8 Overtopping of the West Dam on June 5 recorded (with still image for every minute) by a camera operated by IMO located west of the dam and looking towards southeast. Time and description of each image is as follows: (a) at 10:20 AM, pāhoehoe lava flowing on the surface of solidified crust of the lava field reaches the east end of the dam; (b) at 10:27 AM, lava flow down the slope of the easternmost end of the dam; (c) the lava channel that formed within an hour

is seen here at 14:50 PM, lava has started to creep slowly through lows in the bulldozed heap forming the dam's crest; (d) at 14:51 PM soil dust plumes rise from under the lava flow; (e) at 18:00 PM the lava has overtopped most of the dam; (f) at 20:02 PM the lava has fully covered the dam, except the westernmost heap (Photocredit: Webcam/The Icelandic Met Office)

Soil dust plumes also emerged from the main lava flow over the east end of the West Dam as seen in Fig. 8d. Apart from the east end, the overtopping of the West Dam was very slow. The main dam body remained intact and did not breach, or experience slope failure as observed on the East Dam. Pāhoehoe lava creeping slowly (at a speed < 0.1 m/s) over the heap forming the crest of the West Dam did not cause noticeable erosion or failure of the soil material (Fig. 8), even though this was loosely placed. This interaction between the lava and the dam was identified by studying the still images from the webcam operated by IMO at the West Dam site (Fig. 8). The slow initial lava flow that covered the downstream slope of the West Dam can be considered to have formed a shield, protecting the dam against potential erosion under subsequent and continuing lava flow.

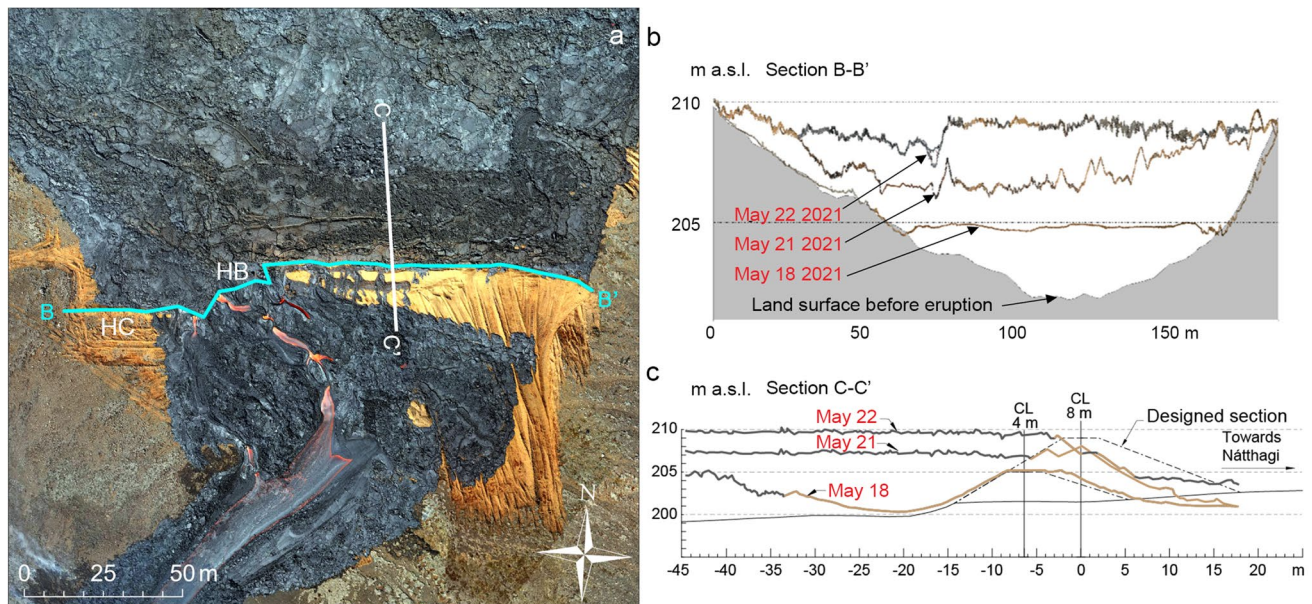
Fig. 9 The East Dam. (a) Plan view (picture from May 22, 2021). (b) Longitudinal section B-B' (along the cyan line on the plan view) as measured by drone survey on May 18, 21, and 22, 2021. (c) Cross section C-C' as measured by drone survey on May 18, 21, and 22, 2021, along with the designed cross section. The black measurement lines represent the surface of the lava, while brownish lines represent the dam's and soil surface. For the May 18 measurement, the brownish line also outlines the heap and the channel between the heap and the dam. The outline of the downstream slope of the elongated heap upstream the dam on May 18, starts ca 32 m upstream the centerline of the designed dam crest (CL 8 m). The outline of the lava for the May 18 measurements starts ca 33.5 m upstream the same center-

line and extends further upstream. The May 21 measurement shows that the lava has piled against the upstream slope to about elevation 207, while on May 22 the lava rises to 1 m above the highest top of the heap forming the dam crest, and lava spilling through the heap B flows along the downstream slope (the black line ca 6 m downstream the centerline of the designed dam crest (CL 8 m)). The May 21 dam outlines show a status during the construction activities on that day, while the May 22 dam outlines present the final bulldozed dam section as completed in the evening of May 21. Data source: The base map is based on data from the National Land Survey of Iceland (www.lmi.is), the IcelandDEM. Data for the lava and the dam: Drone surveys by Svarmi

dam body was not as recommended by the design guidelines, but with loose, uneven crest of heaps. Furthermore, the action initiated on May 21 to increase the height of the heap HB and HC was interrupted due to lava flows at the West Dam site and the heaps remained a weak part in the defences towards the downstream (see May 22 measurements of the dam in Fig. 9b, c).

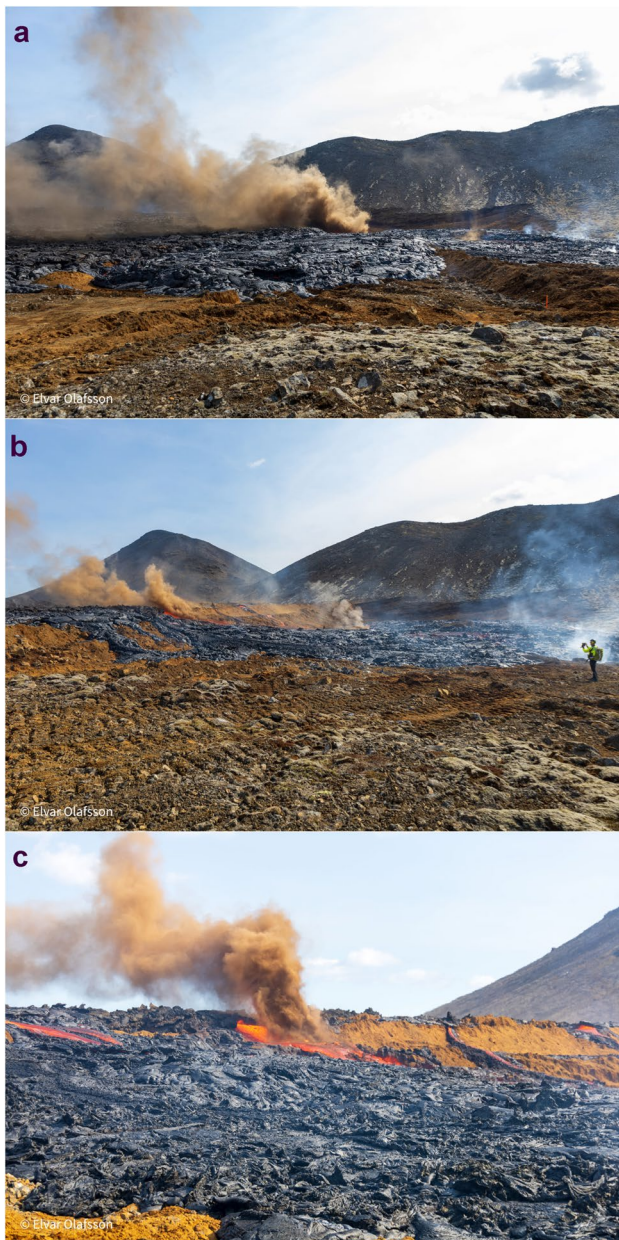
Fig. 11 Lava overtopping of the East Dam on May 22 (courtesy of Elvar Þór Ólafsson). Soil dust plume rose from under the main lava flow over the dam. (a) Seen from the upstream and west of the dam. Heaps HA and HB have been fully overtopped. Only the westernmost end of heap HC is still visible. (b) The overtopping seen from the downstream. (c) Closer view from the downstream of one of the main lava streams at that time and the thick soil dust plume

During the overtopping of the East Dam, at least two main detrimental processes were identified by studying video recordings from one of the webcams operated by the media (RÚV, n.d.). Firstly, lava flow caused slides on the downstream slope as it pushed against the loose heaps. Consequently, a flood of pāhoehoe lava broke through. This initial slope failure and breaching of the heap was possibly partly triggered by hardened crust floating on the surface of the pāhoehoe lava flow as well as lava pressure. However, close-up images were not available to confirm this hypothesis for the failure initiation. Secondly, soil dust plumes, driven by the high temperature of the lava, rose from under concentrated lava flow over the heaps forming the crest of the East Dam (Fig. 11). Similar plumes were also observed as lava rushed down mountain slopes. The soil lofted from under the lava indicates a mechanical or thermo-mechanical erosion process as described by Gallant et al. (2020) for lava flows down steep-sided volcanos. Turbulent eddies were present in the lava flow in the area where the soil plume originated on the East Dam. Such eddies were seen in a video by Ólafsson (2021). Area with the eddies was observed just below a sharp change in the downstream slope, which was

caused by the heap. Glaze et al. (2014) explain that such eddies are produced by the angular momentum generated by the slope change.

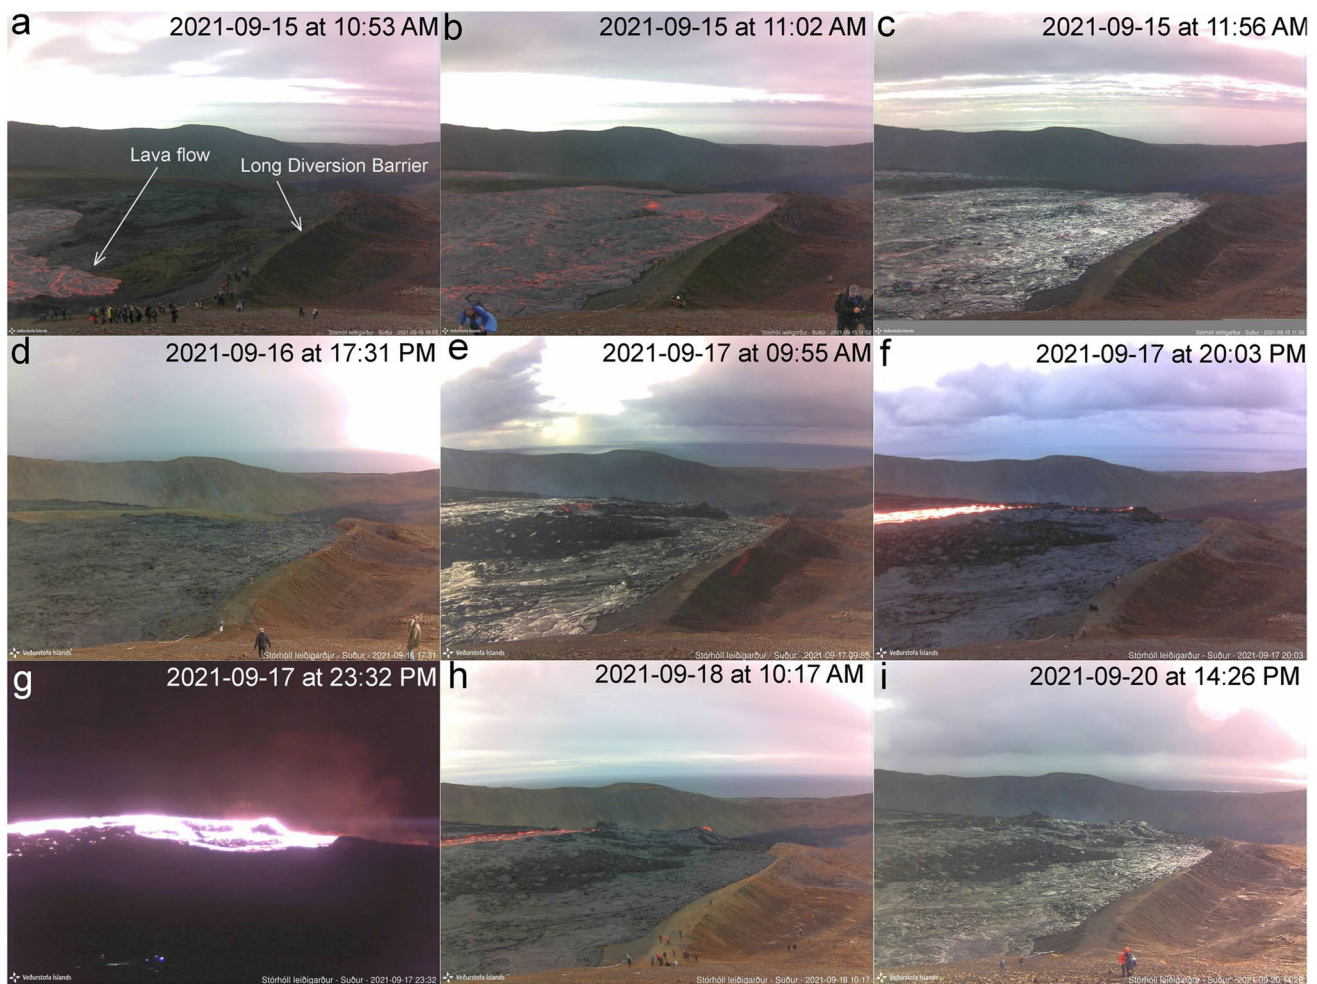
Fig. 14 Images of the Long Diversion Barrier recorded by a webcam looking towards the south (the webcam captured a still image every 10 min). Date and time of each picture frame is as follows: (a) 2021-09-15 at 10:53 AM first lava flow towards the Long Diversion Barrier. (b) 2021-09-15 at 11:02 AM first lava flow along the Long Diversion Barrier. The lava flows along the full length of the diversion barrier. (c) 2021-09-15 at 11:56 AM. The lava flow continues. (d) 2021-09-16 at 17:31 PM. The crust of the lava solidified. (e)

2021-09-17 at 09:55 AM. The levees of the lava channel are overtopped with flow towards the diversion barrier. (f) 2021-09-17 at 20:03 PM. Lava flows within the channel. (g) 2021-09-17 at 23:32 PM. Overtopping of the channel's levees and lava flows towards the lower part of the Long Diversion Barrier. (h) 2021-09-18 at 10:17 AM. Lava flows within the channel. (i) 2021-09-20 at 14:26 PM. Solidified lava surface (Photocredit: Webcam/The Icelandic Met Office)

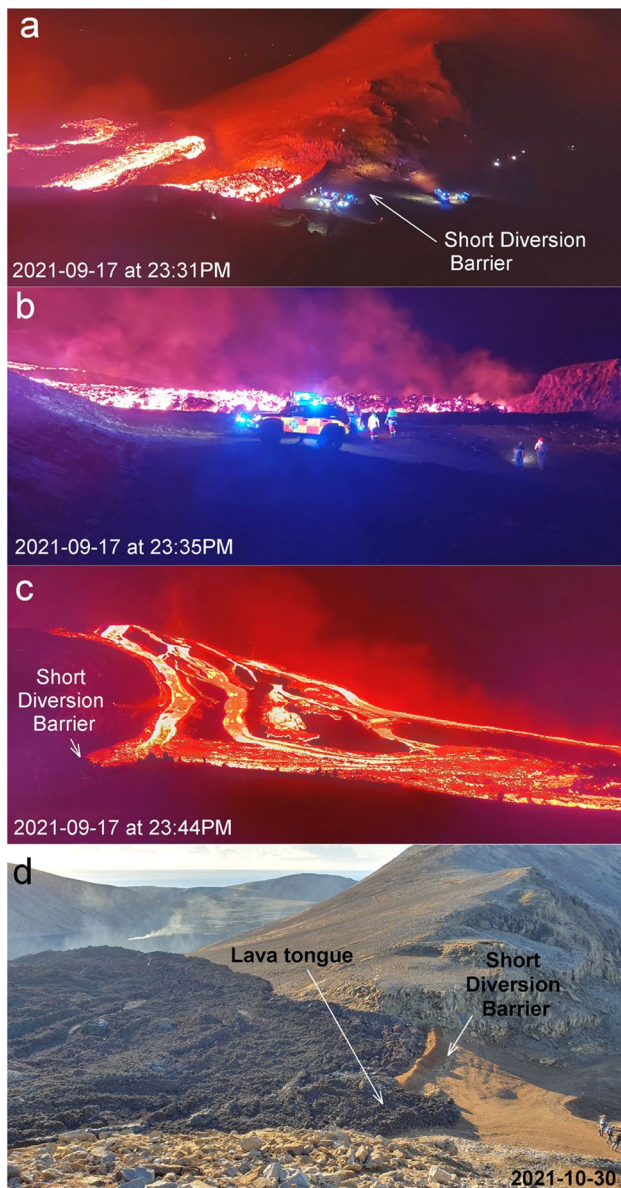
Diversion Barrier (Fig. 15a–c) and Náttagi. The lava accumulated behind the Short Diversion Barrier within the outer bend of the lava flow (Fig. 15c) where it thickened and rose about 2 m above the diversion barrier's crest (Fig. 15b). The lava in the bend moved slower (less than 0.3 m/s) than the fast-flowing lava (at a speed higher than 1 m/s) within the lava channel past the Short Diversion Barrier. Through this effect, the Short Diversion Barrier diverted the lava. Subsequently, the lava surface behind the diversion barrier subsided somewhat. However, the next day, the lava flow continued (Fig. 14h) and one of the lava tongues crawled over the northernmost end of the Short Diversion Barrier (Fig. 15d) where the barrier crossed a hiking trail. Fortunately, the lava

Fig. 15 The Short Diversion Barrier and lava flows. (a) View towards south-southeast over the Short Diversion Barrier and the lava flow on Sept 17 at 23:31 PM. The cars are parked on the Short Diversion Barrier's mild downstream slope (courtesy of Hlynur Lind Leifsson). (b) Lava rising above the thin crest wall of the Short Diversion Barrier on Sept. 17 at 23:35 PM. (view towards southeast) (courtesy of Hlynur Lind Leifsson). (c) The downhill lava flow on Sept. 17 at 23:44 PM (view towards northeast) (courtesy of Hlynur Lind Leifsson). (d) View on Oct 30 towards south-southeast over the Short Diversion Barrier and the hardened lava. The lava tongue at the northernmost (NNE) end of the diversion barrier is the result of a lava flow on Sept 18
