Experience in diverting and containing lava flow by barriers constructed from in situ material during the 2021 Geldingadalir volcanic eruption

Fjóla G. Sigtryggisdóttir¹ · Hörn Hrafnisdóttir² · Jón Haukur Steingrímsson³ · Ari Guðmundsson²

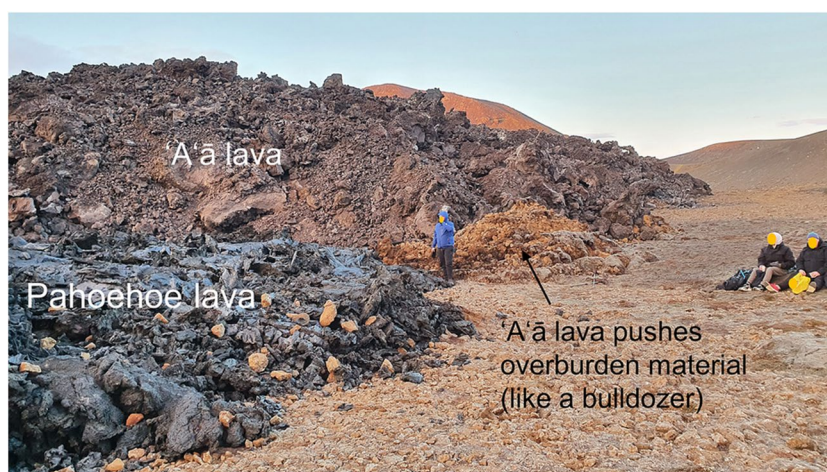
Fig. 2 Pāhoehoe and ‘a‘ā lava fronts in the SM Valley on May 8, 2021

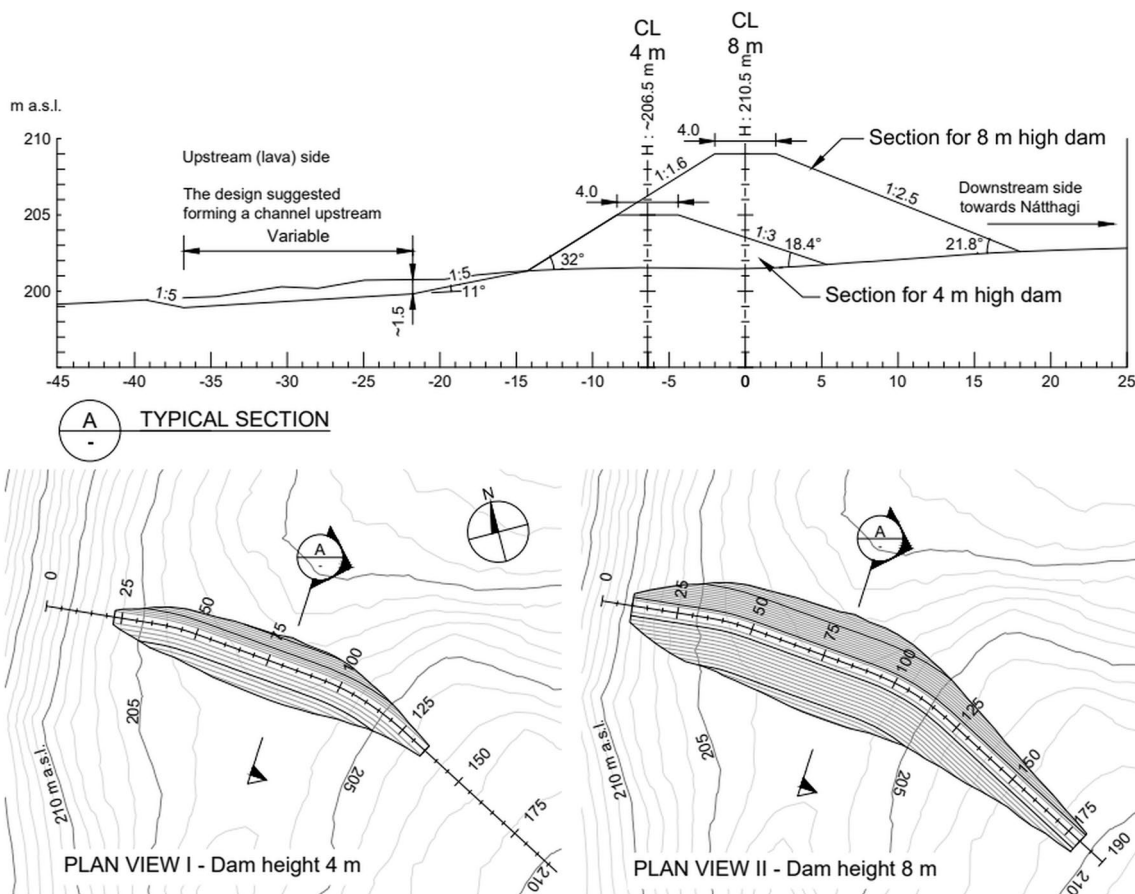
Fig. 3 The geometry the West Dam in the SM Valley, according to the preliminary guidelines. Typical cross section (A) and plan layouts for 4 m high (Plan view I-Phase I) and 8 m high (Plan view II-Phase

The design drawing, Fig. 3, of the West Dam, also applied for the East Dam. The drawing proposed the minimum cross-section from the preliminary guidelines in the case of limited construction material at the site. The minimum cross-section was intended to provide sufficient resistance against lava pressure from its weight. Still, the guidelines recommended a wider crest and cross-section to enable two-way traffic of construction equipment on the dam, as well as to be able to increase the dam height faster, if needed. Colombrina (1984)

recommended, for example, a wide cross-section for these reasons. In Fig. 3, the dam is placed with its foundation inclined upward towards the downstream, requiring a larger force or pressure from the lava to cause sliding of the dam body compared to a dam placed on near horizontal foundation.

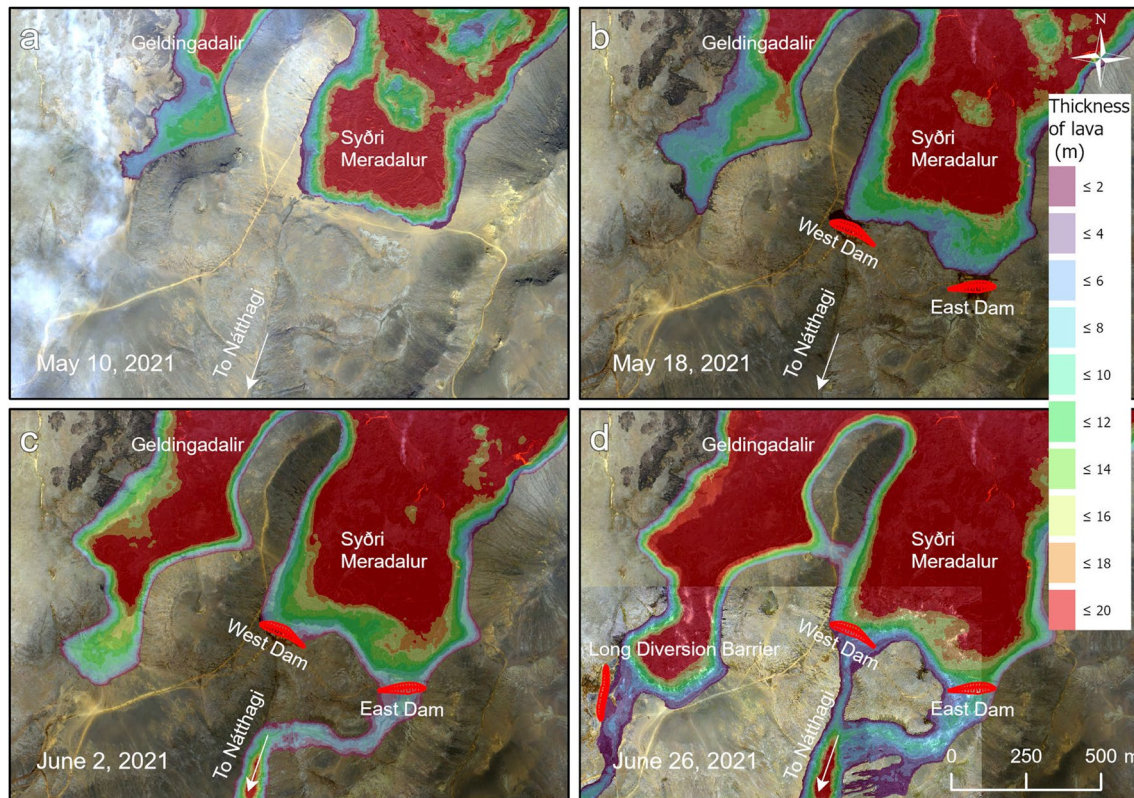
Fig. 4 Status of the lava flow and thickness, and construction of barriers. (a) May 10, 2021. (b) May 18, 2021. (c) June 2, 2021 and (d) June 26, 2021. The West Dam and East Dam (constructed from May 13 to 21, 2021) and the Long Diversion Barrier (constructed from

This section describes the construction of the dams and diversion barriers and the interaction with lava during the construction. Figure 4 shows the expansion of the lava field and lava thickness in the area of the dams and the Long Diversion Barrier on four different dates. Figure 4a shows the status on May 10, 3 days before construction started.

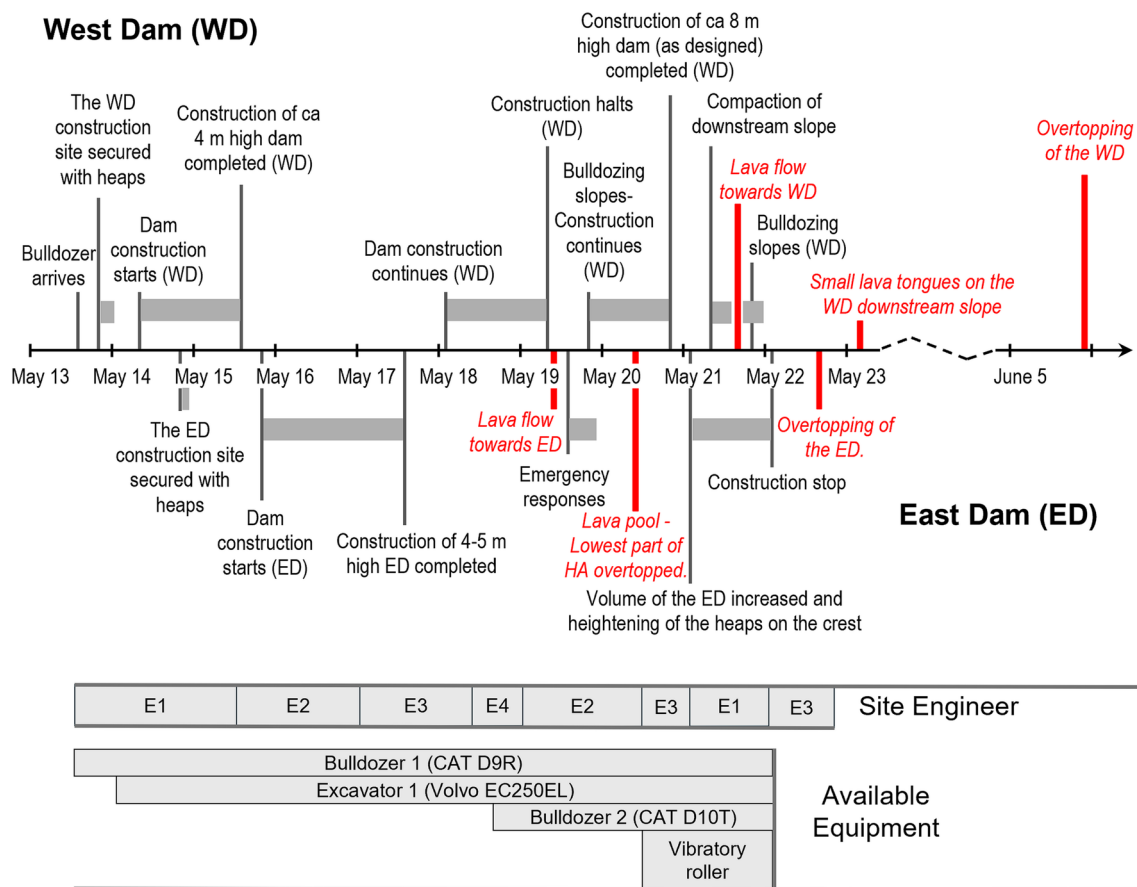
Fig. 5 Timeline for construction of the West Dam and East Dam, along with lava flows occurrences, availability of the different construction equipment and different site engineers on duty

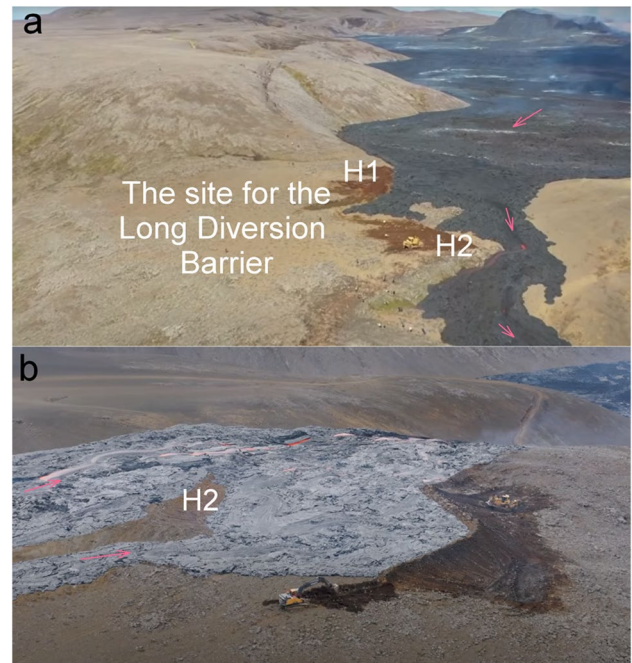
Fig. 12 Securing the construction site of the Long Diversion Barrier. The direction of lava flow is indicated with red arrows. (a) On June 14, site material pushed to form heaps (H1 and H2) against the lava stream. The crater is seen in the upper right corner of the figure (view towards north) (courtesy of Gylfi Gylfason, snapshot from a JustIcelandic video <https://www.youtube.com/watch?v=kcdYOzKcc8Q>). (b) On June 15, the bulldozers surround lava flow running along the margin of the existing lava field, passing and running downstream of the heaps H1 and H2 (view towards the South-southeast) (courtesy of Visit Reykjanes, snapshot from their video <https://www.youtube.com/watch?v=qPShqWZCYxM>)

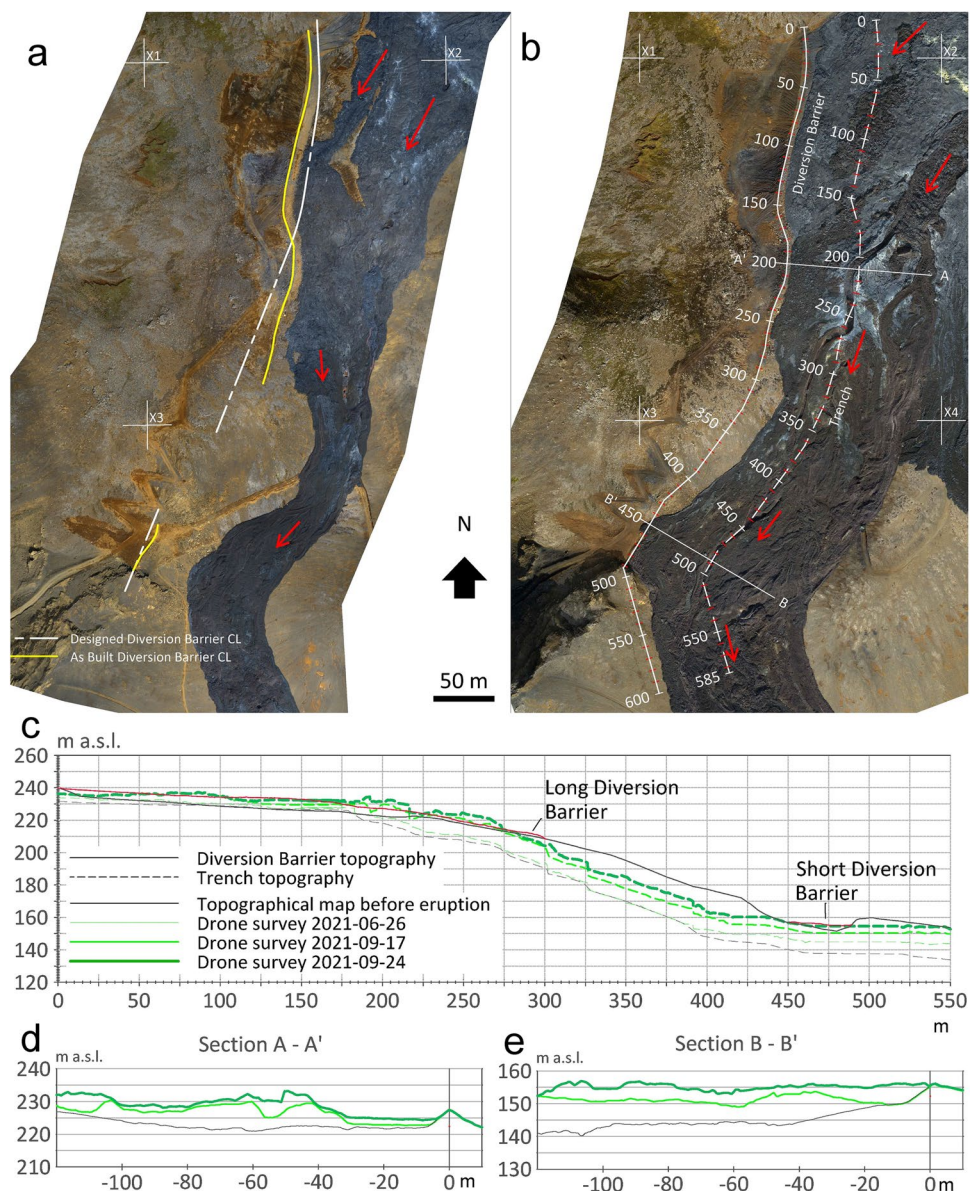
flowed towards the Long Diversion Barrier (Fig. 14a). The lava flow advanced at an angle of about 20° to the longitudinal direction of the Long Diversion Barrier (Fig. 13) and turned to flow alongside the diversion barrier (Fig. 14b). Thus, the Long Diversion Barrier diverted the lava flow successfully towards Nátthagi (Fig. 14b, c). Comparing Fig. 14a and b, the lava flowed along the entire length of the Long

On September 16, a lava channel started to form. By September 17, the lava channel had developed further (Fig. 14e, f), swaying towards the south approximately 120 m from the Long Diversion Barrier, then running almost alongside the diversion barrier, closest at about 55 m (Fig. 13b). Then, the lava flowed down the mountain slope into Nátthagi Valley, expanding towards the banks on each side as well as towards the Short Diversion Barrier (Fig. 13a, b).

Fig. 13 The Long Diversion Barrier and the Short Diversion Barrier. **(a)** Aerial view with drone surveys from June 26. The white (dashed-dot) line and the yellow line are respectively the designed and as-built centreline (CL) of the diversion barriers. The direction of lava flow is approximately indicated with the red arrows. **(b)** Aerial view with drone surveys from September 24. Station numbers along and connecting the centreline of the diversion barrier are provided. A 60 m offset of the diversion barrier's CL is also shown with a dashed line and runs partly parallel to the lava trench (labelled "Trench"). **(c)** Longitudinal section along the two centrelines in fig. b. The different dashed lines show the topography along the trench at different times. The as-built crest of the diversion barriers is plotted with a thin red solid line. **(d)** Cross section A-A' through the Long Diversion Barrier at station 0/200 (see fig. b). Legend is provided in fig. c. **(e)** Cross section B-B' through the Short Diversion Barrier at station 0/475 (see fig. b). Legend is provided in fig. c. Data source: The base map is based on data from the National Land Survey of Iceland (www.lmi.is), the IcelandDEM. Data for the lava and the diversion barriers: Drone surveys by Efla
